SENECA FALLS DAM

PHASE I INSPECTION REPORT NATIONAL DAM SAFETY PROGRAM

NY 00708

Prepared by: O'Brien and Gere Engineers, Inc.

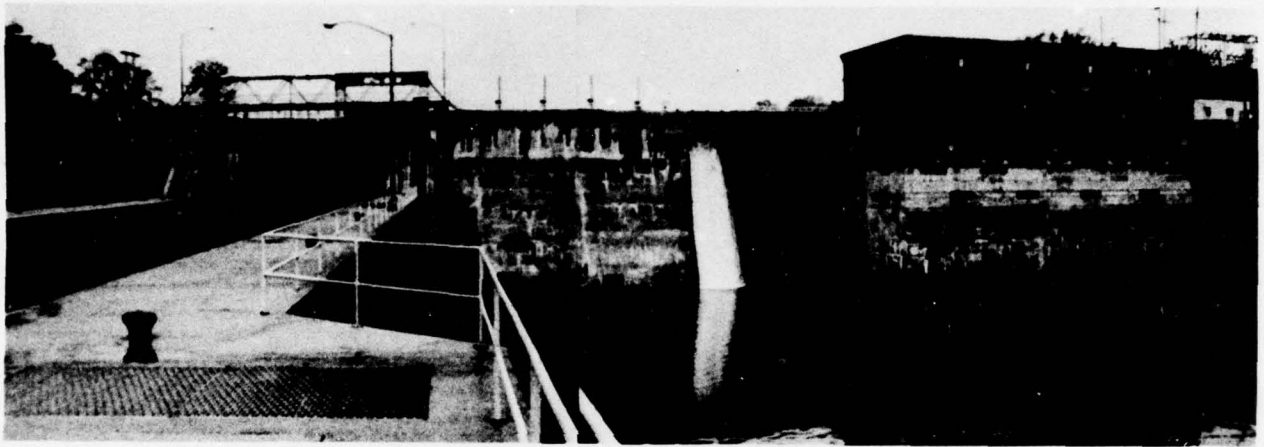
OVERALL VIEW OF DAM

The Seneca Falls Dam appears to be in good condition and is well maintained. No significant deficiencies were noted during the visual inspection. However, based on the hydrologic analysis, the Probable Maximum Flood (PMF) would cause overtopping of the dam by about 7 feet. The concrete structures might withstand overtopping, but severe damage or failure of the earth embankments would be expected.

Results of the hydrologic/hydraulic analysis indicate that the dam would be overtopped by all floods exceeding approximately 11 per cent of the PMF; therefore, the spillway can be considered "seriously inadequate" as cited in Engineering Technical Letter No. 1110-2, January 25, 1978. A detailed hydrologic/hydraulic analysis of the PMF is recommended to be done immediately for this structure, taking into account the effects of alternative operational procedures, and including the effects of Seneca Lake and upstream regulating structures on the flood wave. If the results of the analysis confirm that the dam cannot pass at least one half of the PMF without overtopping, remedial measures should then be recommended. In the interim period, around-the-clock surveillance should be provided during periods of high flow, and a contingency plan initiated for implementation in the event of overtopping.
